# Manhole Inspection Summary

Manhole # S35MM\_026MH

Insp Date: **4/5/07 1:18 PM**

**Location** Address: **101 21ST ST**

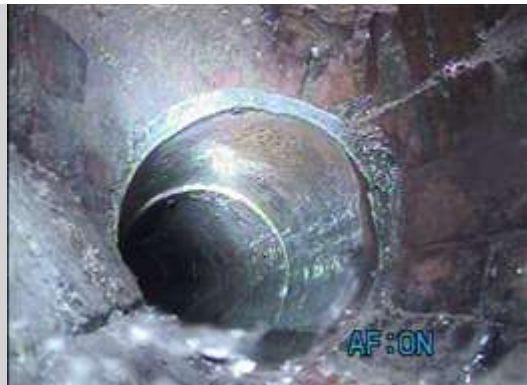
### 8 in. Circular Gravity Sewer Pipe In @ 3 O'Clock

Pipe Material: **Clay** ☐ Pipe Lined

Invert Depth: **8.70** (ft.) Flow Characteristics: **Slow**

Infiltration: **None** Pipe Seal Cond: **Unknown**

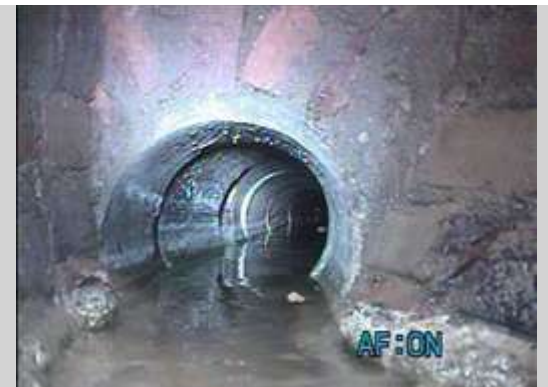
### 8 in. Circular Gravity Sewer

Pipe Material: **Clay** ☐ Pipe Lined

Infiltration: **None** Pipe Seal Cond: **Unknown**
